County of San Diego
Woodside Avenue Extended Detention Basin
Effectiveness Assessment Monitoring
Grant Agreement No. 04-067-559-0

Draft Interim Report

July 2006

**Weston Solutions, Inc.
2433 Impala Drive
Carlsbad, California 92010**

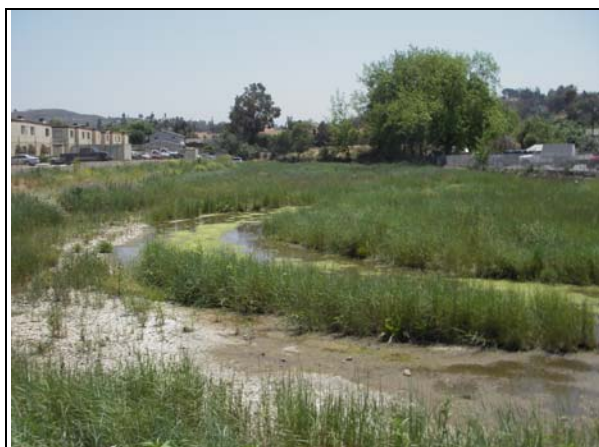
Figure 1. Woodside EDB, May 16, 2006

This project was constructed as an Extended Detention Basin (EDB) as shown in Figure 1 and is intended to provide water quality treatment for low storm flows and nuisance urban runoff passing through the site before they reach Los Coches Creek and the San Diego River. Figure 2, on the following page illustrates the design of the EDB. The basin was excavated to allow runoff to flow from the two influent conveyances, through the EDB, and then discharge at a controlled flow rate to allow for temporary detention up to the design storm. Prior to construction of the EDB, dry and wet

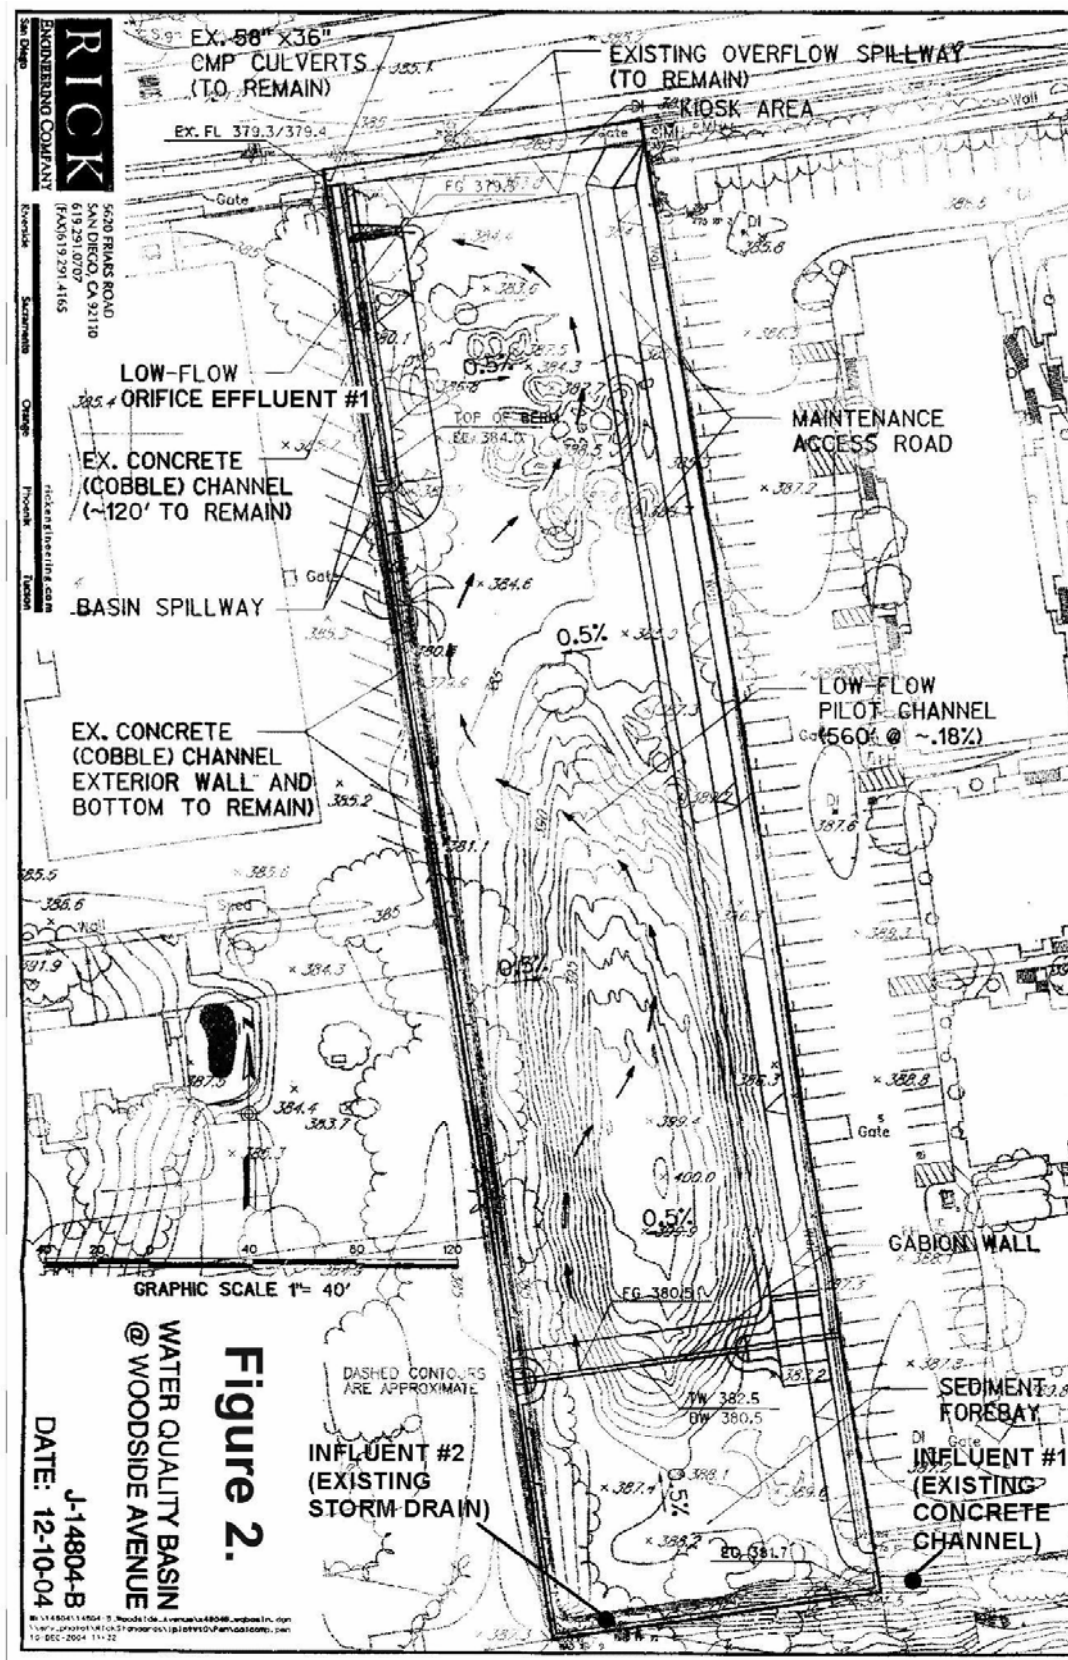
Figure 2. EDB Design

weather flows traveled into the cobble-lined channel then discharged from the site without detention or treatment. Storm water and nuisance flows currently enter the site through the two influent channels shown on Figure 2. At both influent locations rip-rap has been placed to reduce the velocity of the influent to allow large particles and debris to settle out. The dry and wet weather flows then pass through a gabion wall which provides for additional settlement and some filtering. Low flows are then directed into a vegetated sinuous channel through the basin before discharging through a low flow orifice at the effluent end of the basin. The vegetated channel provides for additional settlement and acts as a bioswale to address total suspended solids (TSS), nutrients and some bacteria. Storm flows up to the design storm event will flow over the gabion wall and pond behind the weir (spillway) in which the low flow effluent discharge point is located. The design storm is held to allow for additional settlement of smaller particles to reduce the concentrations of TSS, metals and nutrients in the effluent. As a flood control facility, during high flows the gabion wall is circumvented and water passes over a spillway at the effluent end of the basin. This design reduces the possibility of upstream flooding; however, optimal water quality treatment will not be achieved during storm events that are greater than the basin's storage capacity. The emergency bypass valve at the EDB's effluent location can also be opened during large storm events.

The constructed EDB covers an area of 1.7 acres and has an approximate depth of 5.5 feet, however, only 4.5 feet is utilized for water quality treatment. The length to width ratio is very desirable, approximately 5:1. The water quality basin is sized to capture the maximum extent practicable (MEP) of the water quality volume based on horizontal and vertical constraints through the project (Rick Engineering, 2006).

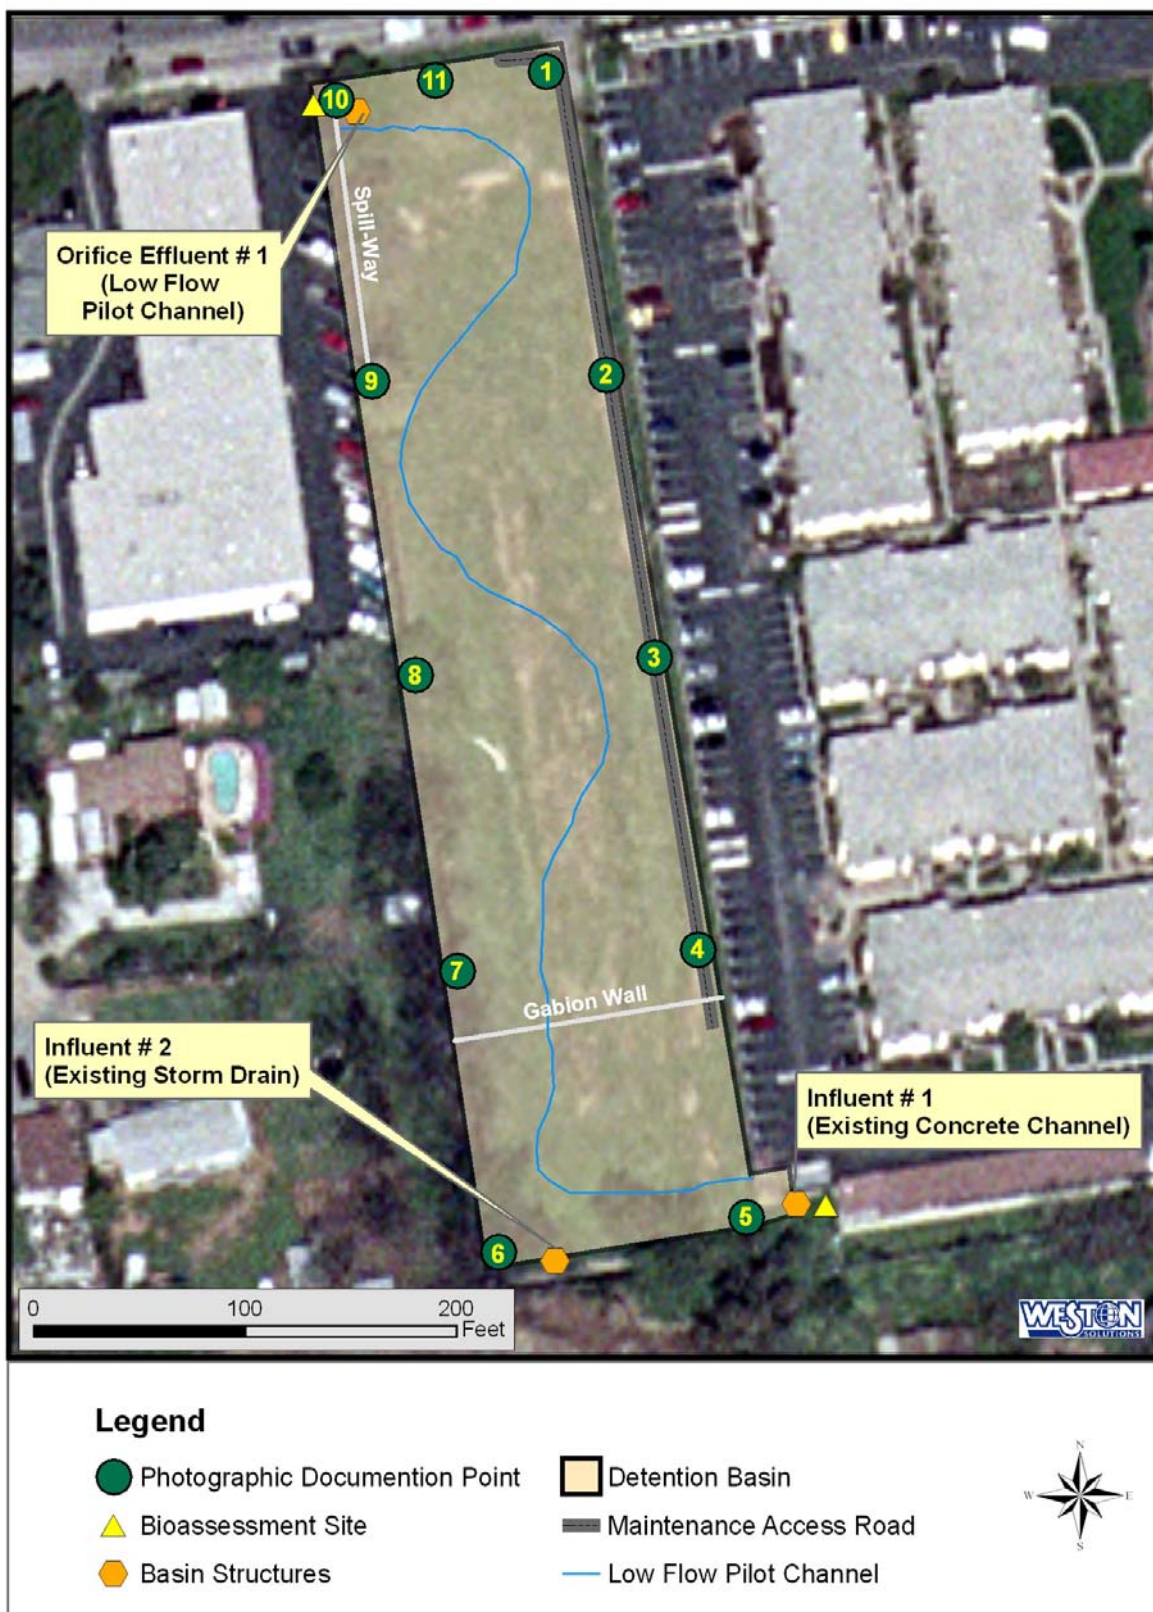
Figure 4. Sampling Points

Water quality measurements are taken at bioassessment locations. These sampling locations are shown on Figure 4. Measurements include water temperature, conductivity, pH, and dissolved oxygen. Once sample containers are filled they are labeled and 95% ethanol is added. Labels denote station identification; transect number, stream name, date, times, sampling device, and sampler's initials. Within 24 hours the ethanol is decanted and replaced with fresh ethanol. No special handling or custody procedures are needed. The chain of custody form is used as a shipping record. Samples are disposed of when analysis is completed and all analytical quality assurance/quality control procedures are reviewed and accepted.

In order to assess BMP performance, two sampling locations were selected upstream of the EDB and one station was selected at the end of the low flow out flow pipe. These sampling locations are shown in Figure 4. Other site selection factors included:

Two influent samples are collected prior to discharge into the sediment forebay. The first sample is collected in the concrete channel that flows into the basin (Influent #1). This reach of the incoming channel parallels Woodside Avenue. The second influent sample is collected from the storm drain pipe that discharges directly into the southern end of the basin (Influent #2). Flow by the basin is regulated through the use of an outflow structure (Effluent #1). Monitoring of the discharge from the basin occurs in the low flow pipe exiting the outflow structure. The effluent sample is collected from the low-flow orifice discharge from the EDB. Sampling of the effluent is discontinued when the water level in the detention basin overtops the basin spillway in order to assure proper assessment of the data for pollutant removal efficiency.

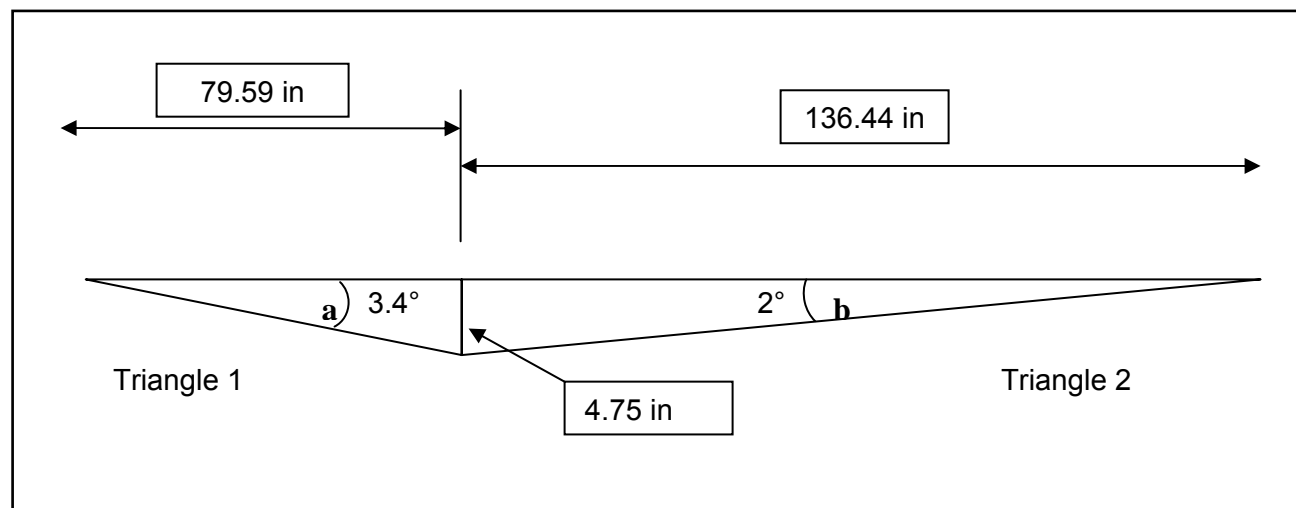
Figure 5. Cross Sectional Area of Channel Bottom

Cross-sectional stream area was based on measurements taken in the field (Table 1) and estimated using the area of two right triangles for the lower portion of the channel. The area of a rectangle was used for any measurements above 4.75 inches, as the channel shape was rectangular at this point. Based upon lower channel total stream width and maximum depth, the area of the two right triangles was estimated as a function of stream height. To determine the area of the triangles at different heights, an estimate of the triangle base was calculated. The shore-side angle of triangles 1 and 2 (Figure 5, angles a and b) was calculated as the tangent of the opposite (height) and adjacent (base) measurements. (Figure 5, angles a and b). Using the relationship between similar triangles, the proportional difference between the maximum depth (4.75 inches) and measured height was used to estimate the base length in inches (Equations 2 and 3). The same procedure was completed for both triangles as a function of height. Area of the triangles was calculated as normal, and if the height of the stream was above 4.75 inches, a cross-sectional area based upon the stream width and height above the lower portion was estimated and added to the lower channel cross-sectional area.

Hydraulic Radius, the third term in Equation 1, is the cross sectional area divided by the wetted perimeter. The wetted perimeter was estimated as the hypotenuse of both triangles plus the height above the lower channel multiplied by two.

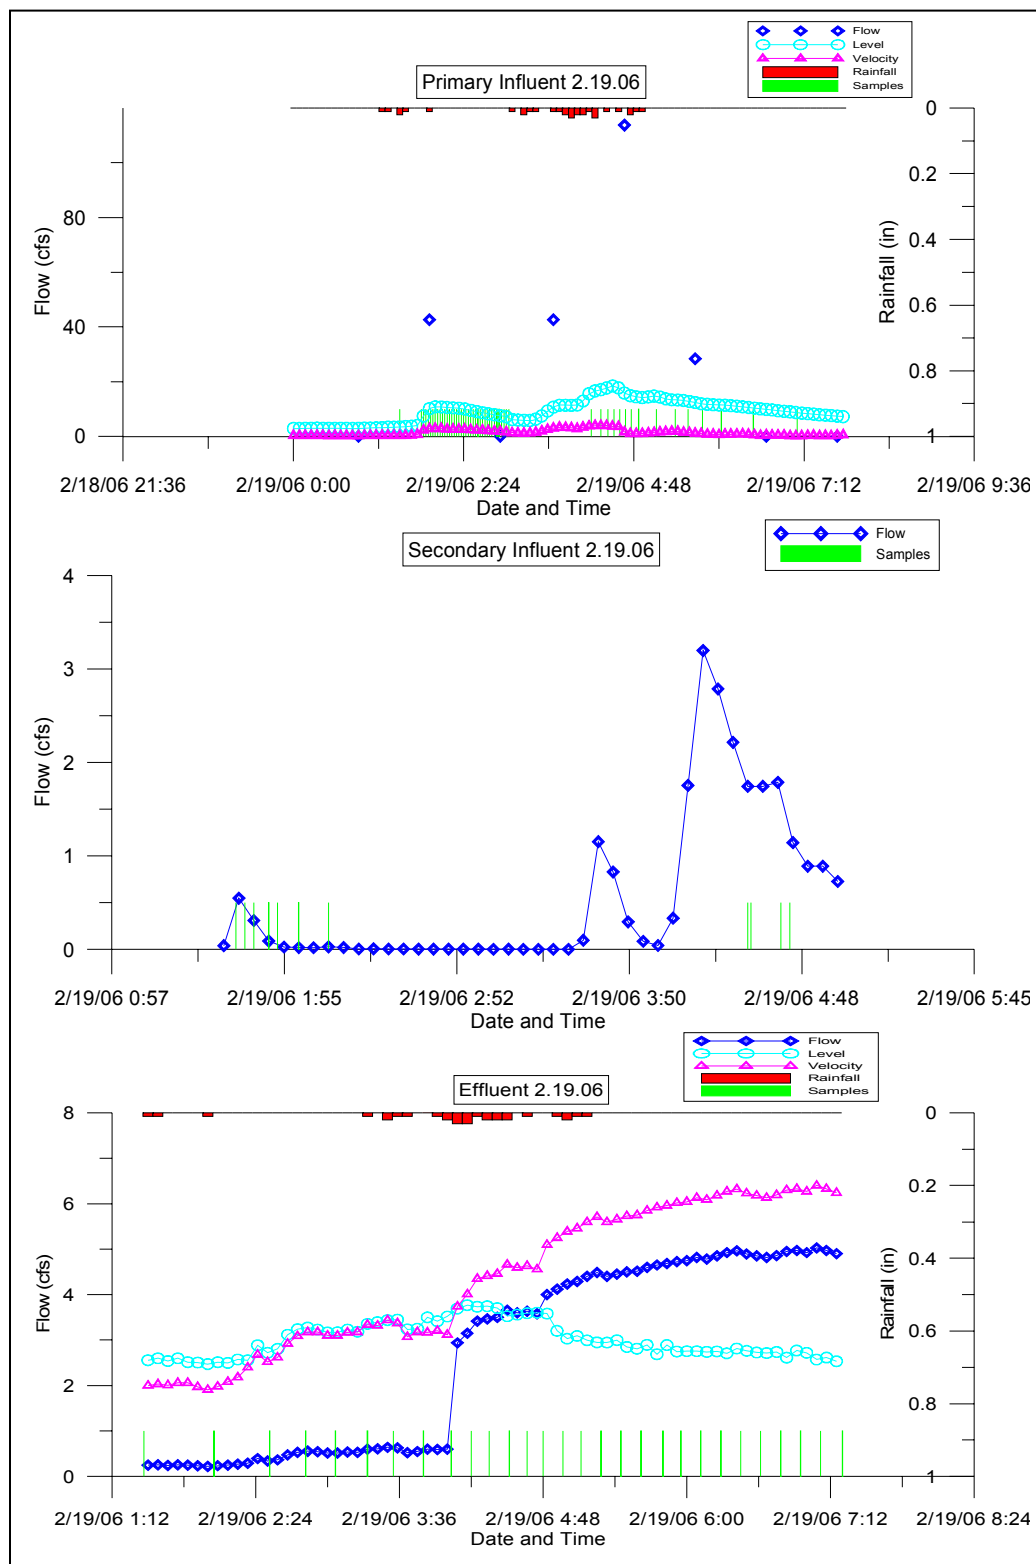
Figure 6. Storm Event #1—February 19, 2006

Hydrographs for primary influent, secondary influent, and effluent, are presented in Figure 6 through Figure 10 in chronological order for the 5 successful storm sampling events.

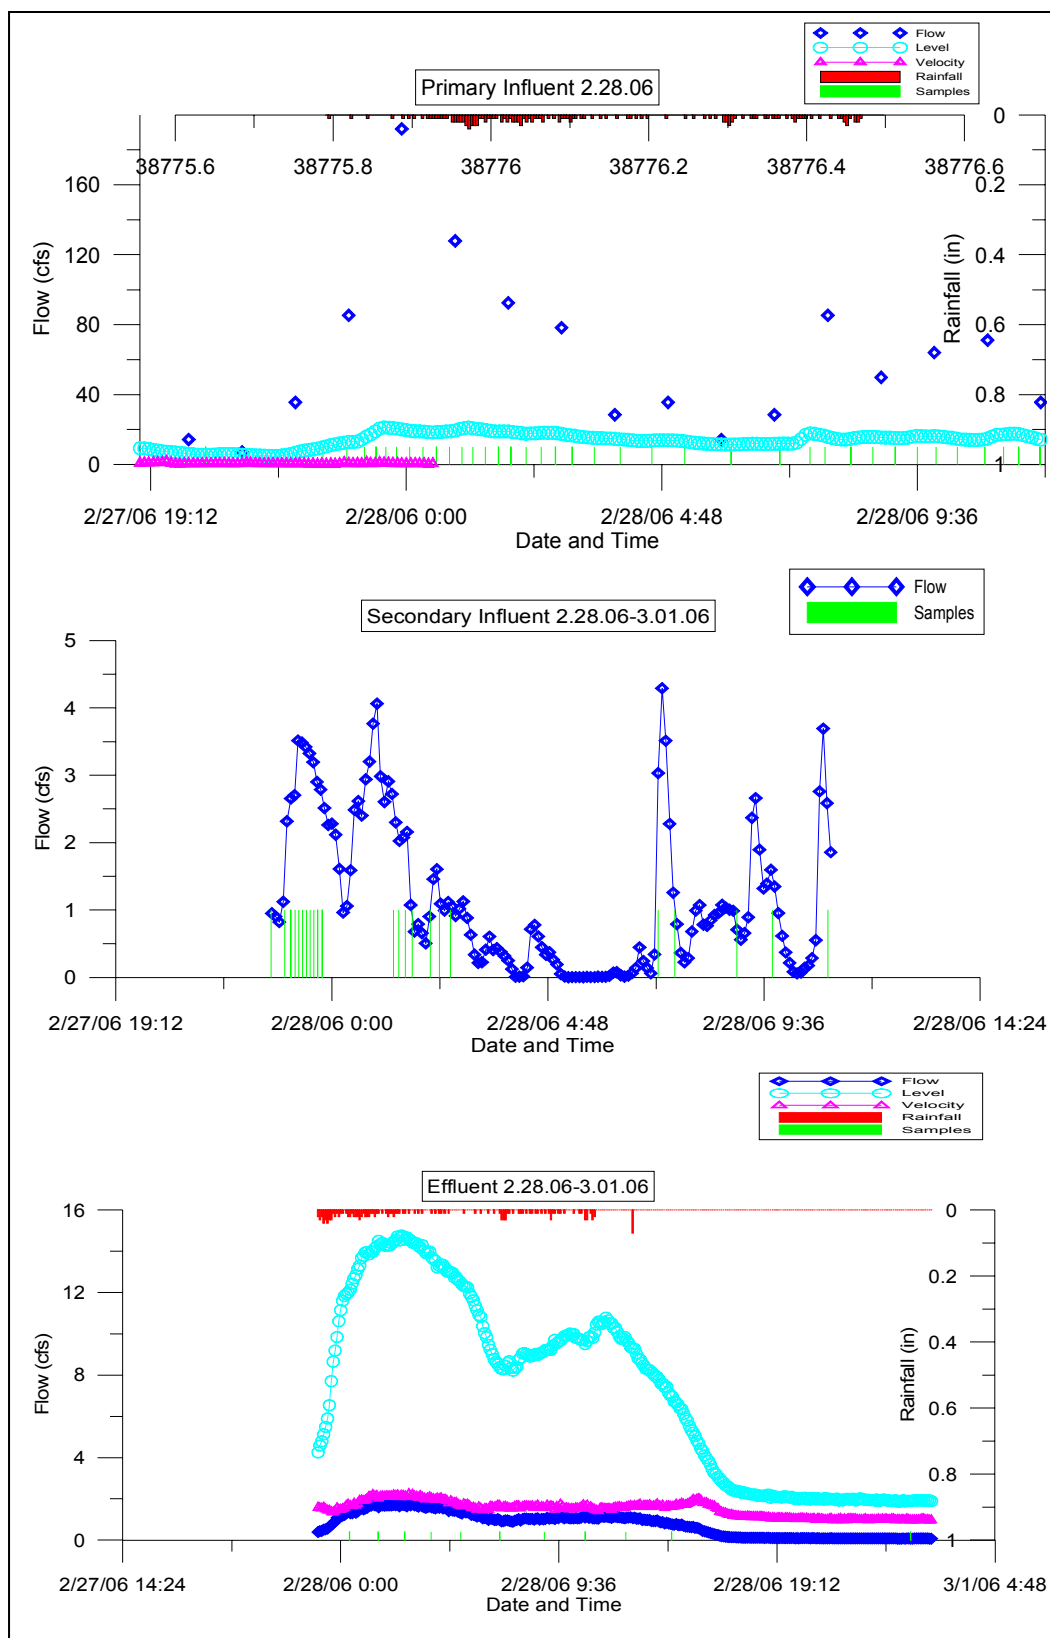
Figure 7. Storm Event #2—February 28, 2006 through March 1, 2006

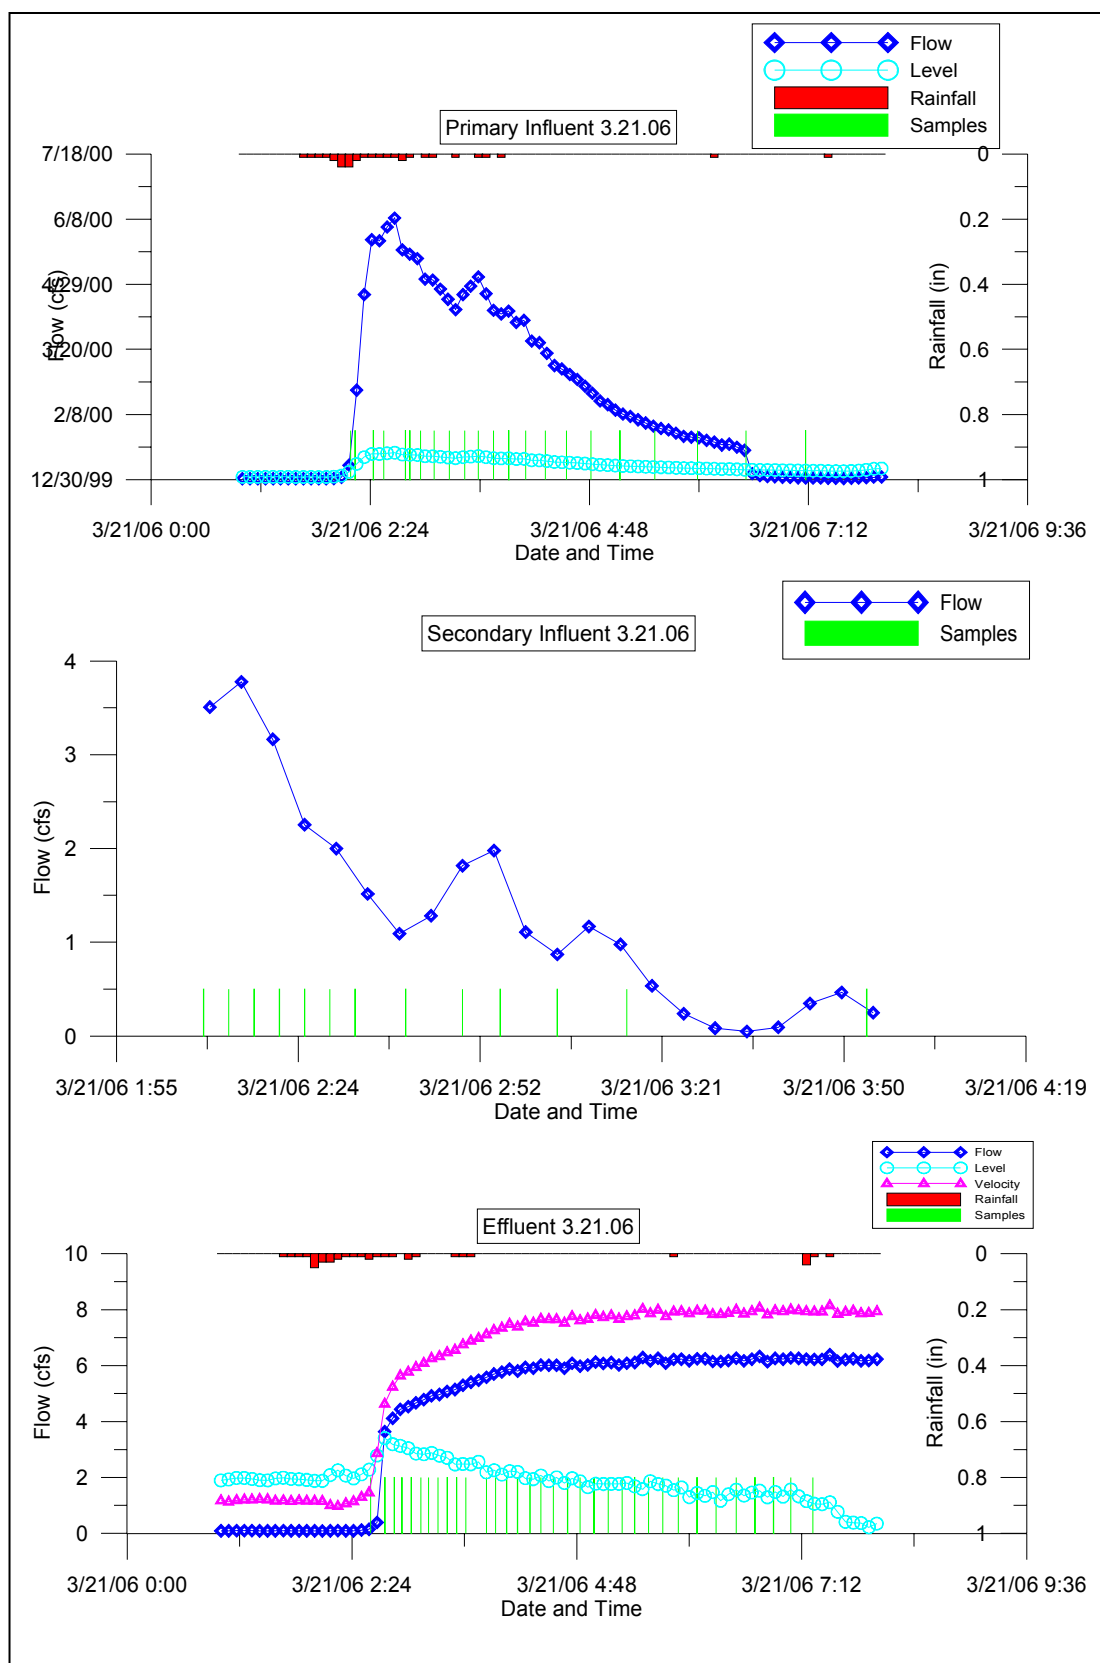
Figure 8. Storm Event #3—March 21, 2006

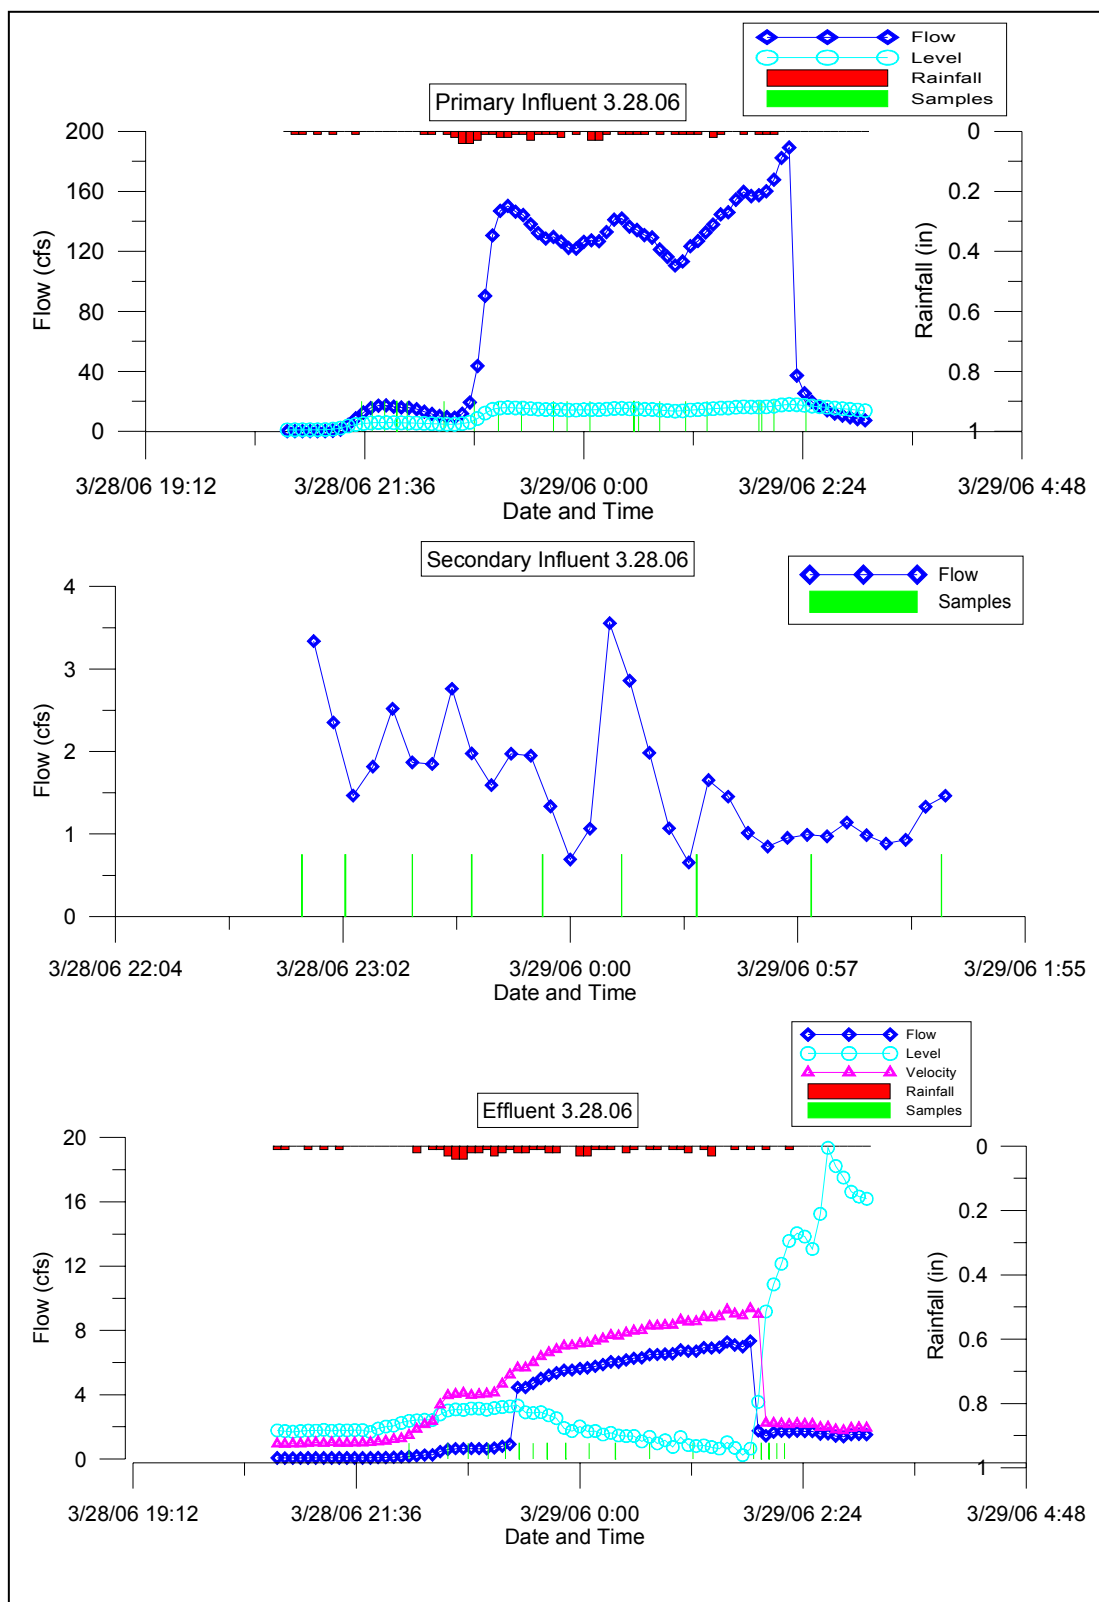
Figure 9. Storm Event #4—March 28, 2006

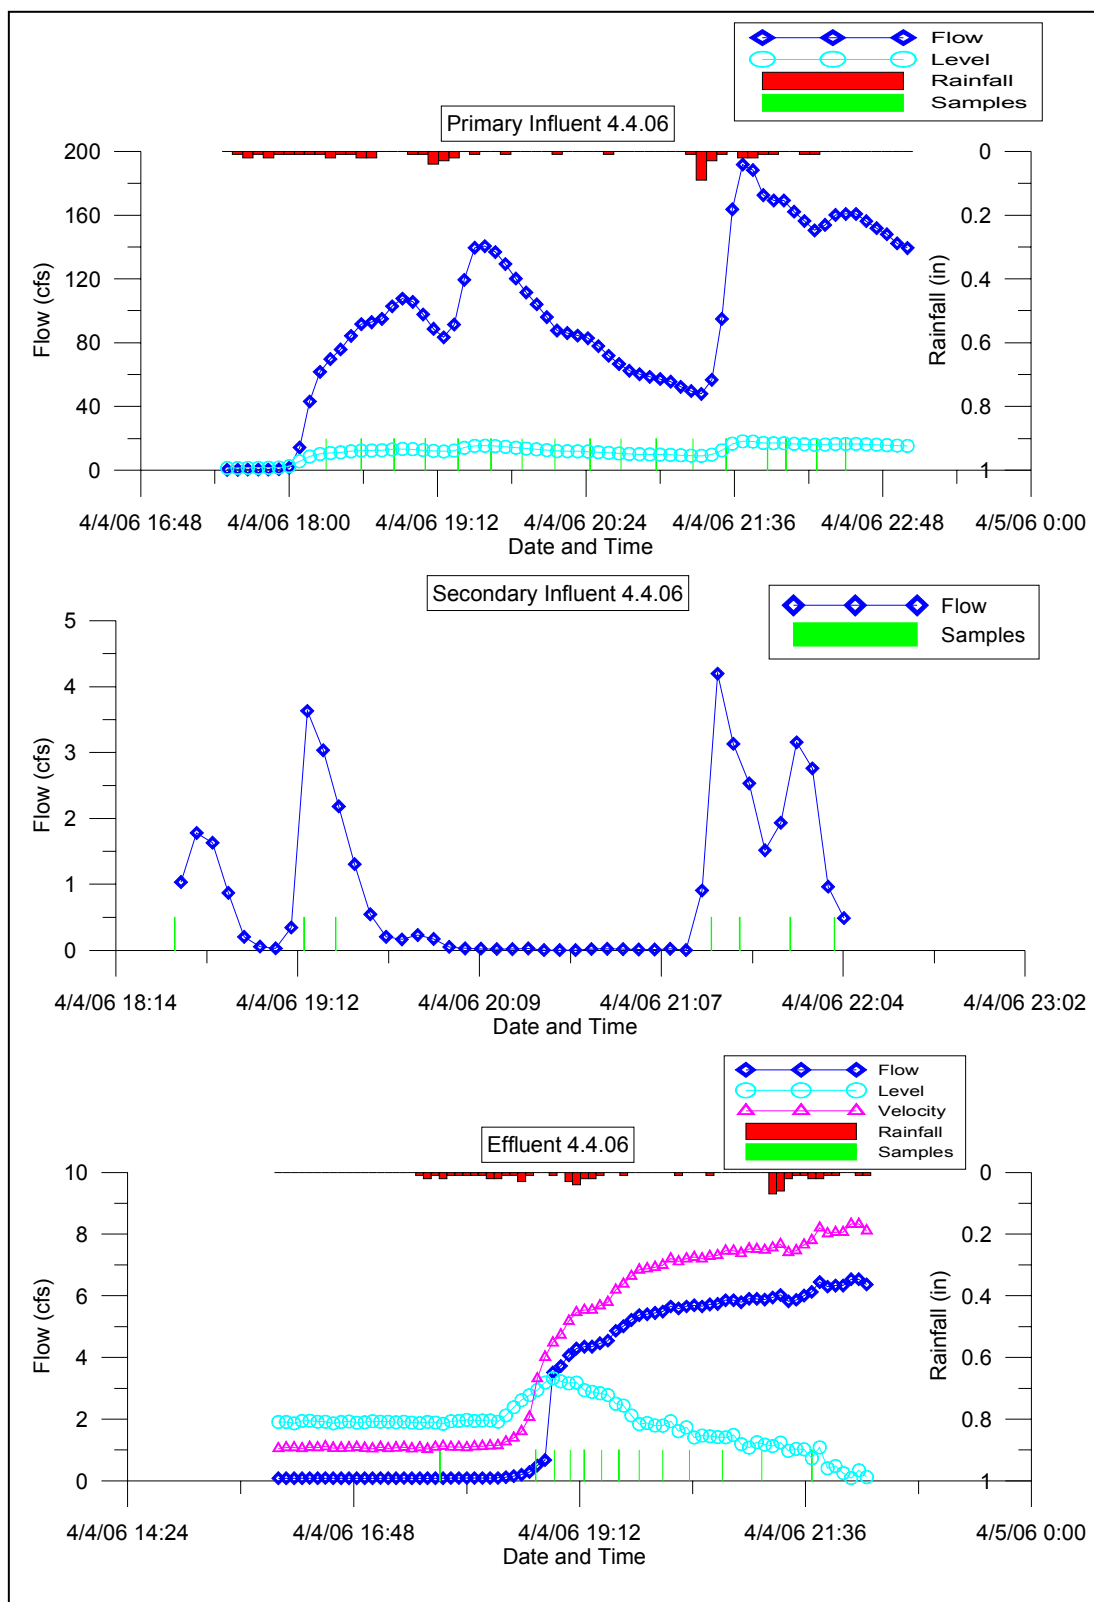
**Figure 10. Storm Event #5—April 4, 2006**

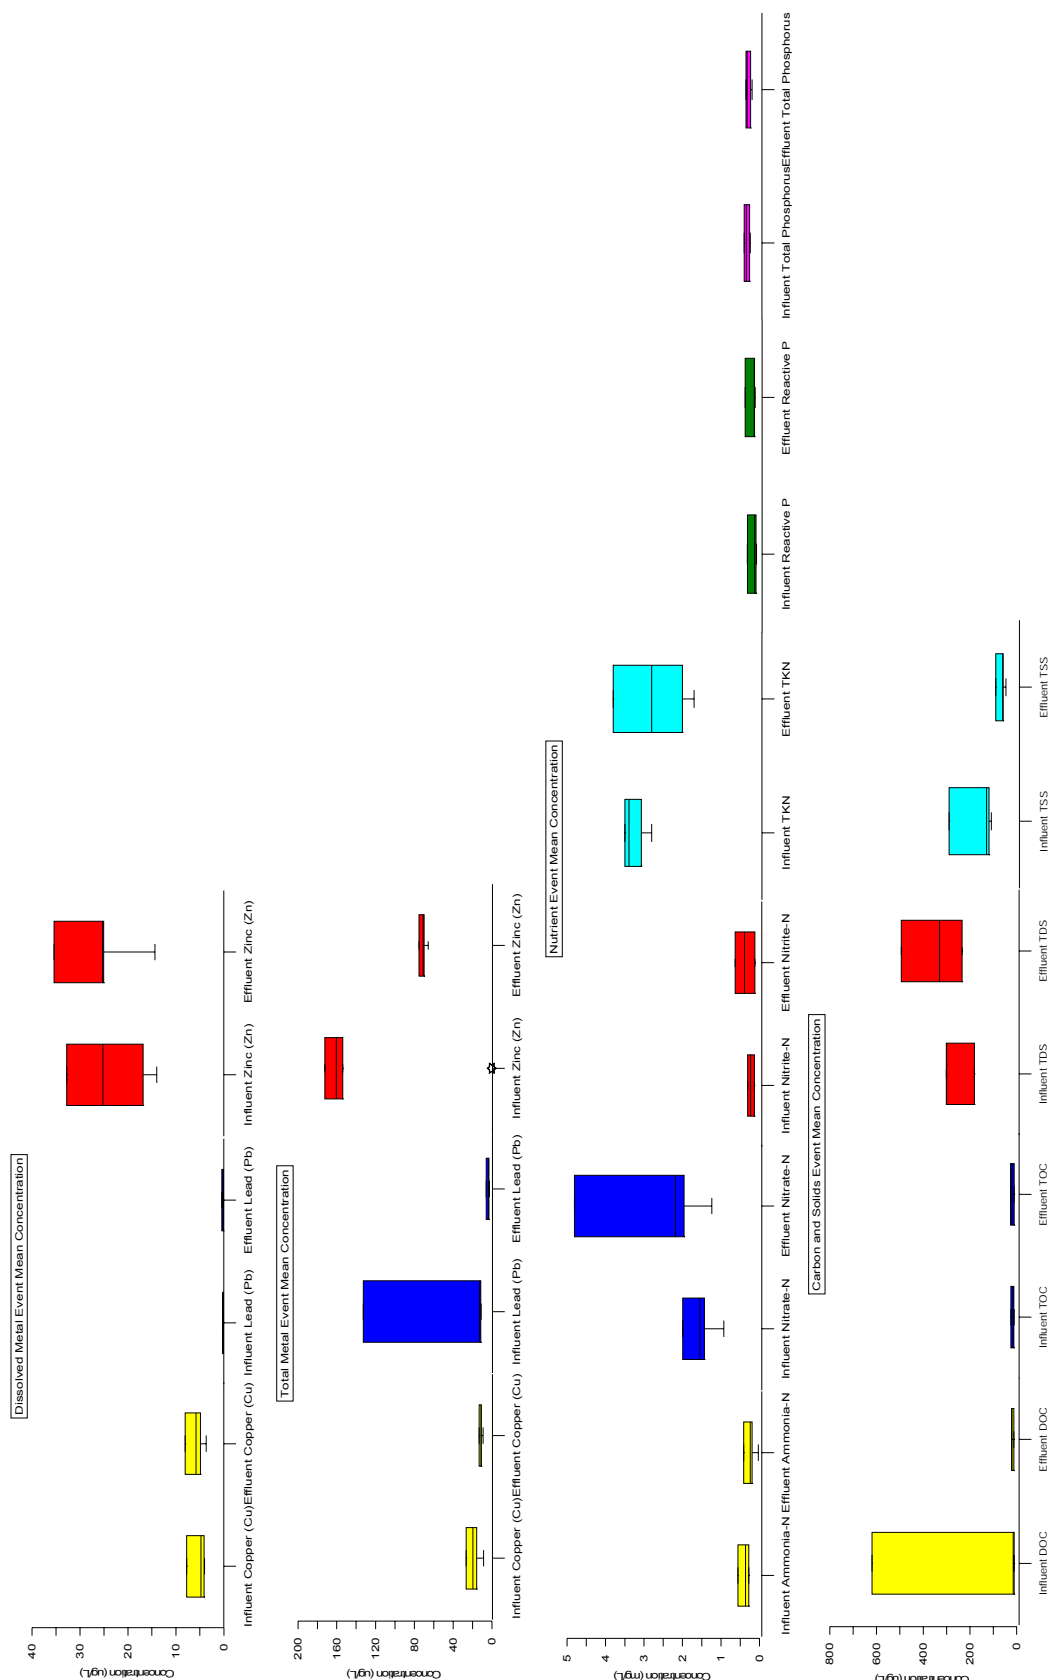
Figure 11. Box and whisker plots for the weighted sum event mean concentration influents and EMC effluents

The results of the Wilcoxon Signed Rank test are presented in Table 9. Of the 16 analytes, 7 were found to be different when comparing influent and effluent. These are listed as "Reject". All of the total metals, nitrate, total phosphorus, and total suspended solids resulted in a rejection of the null hypothesis, or that event mean concentrations for these analytes are statistically lower in the effluent than in the influent. Therefore, the results indicate that the EDB is effective in reducing the influent flow concentration of these seven constituents. Box and whisker plots for the weighted sum event mean concentration influents and EMC effluents are presented in Figure 11.
